Home Tips®

• CHRISTIAN BUILDING INSPECTORS, INC., 1003 STAR COURT, NORCROSS, GEORGIA 30093, (770) 925-8518 • MARCH 1999 •

Defective Roof Shingles?

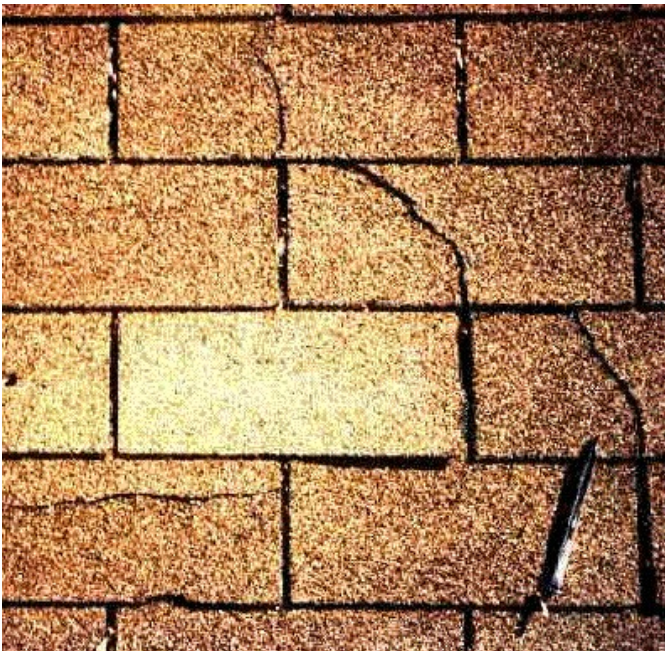
What Does It Look Like?

We have observed a variety of torn or split shingles:

- It's possible that shingles made by some manufacturers do not meet the ASTM Standards for tear resistance.
- Even where shingles meet the Standards, it's possible that the standards themselves were defective.
- In any case, the fiberglass mat may lack adequate tear resistance.

- Self-sealing tabs on shingle backs may glue shingles together with too much strength, causing the roof covering to form a single large membrane which cannot accommodate large temperature changes.

- Reduced total amount of asphalt in thin fiberglass mats might become brittle after exposure to heat and sunlight.
- Temperature swings probably contribute to the onset and extent of tearing, and we'd expect worse tearing where temperature swings are more extreme such as in Northern climates.

- Nailing or placement pattern of shingles: "laddering" vs. "staggered." On laminate and strip type shingles we have inspected roofs on which damage is found occurring at the corners of shingles rather than in the middle of the shingle material. It appears that as temperatures dropped and the glued-together-roof-membrane cools and contracts, the natural point at which movement occurs is where shingles are end-butted together. When the pattern of end-butts is laddered rather than staggered up the roof we have found corners tearing off of shingles following the laddering pattern exactly. (Laddering is not a recommended installation pattern according to NRCA and ARMA publications nor according to instructions from some manufacturers.) Laddering alone cannot be blamed for this failure however, as we have seen similar shingle tearing following a staggered end-but pattern up other roofs. However laddering may indeed create a more localized natural point of separation on a roof, causing most of the movement to occur in a smaller area when the roof material contracts with cooling this type of product.
